REMOVAL REPORT
FOR
DIAZ INTERMEDIATES CORPORATION SITE
301 WYANOKE ROAD
WEST MEMPHIS, CRITTENDEN COUNTY, ARKANSAS

**REMOVAL ASSESSMENT REPORT
FOR
DIAZ INTERMEDIATES CORPORATION SITE

301 WYANOKE ROAD
WEST MEMPHIS, CRITTENDEN COUNTY, ARKANSAS**

Date Prepared:
October 27, 2008

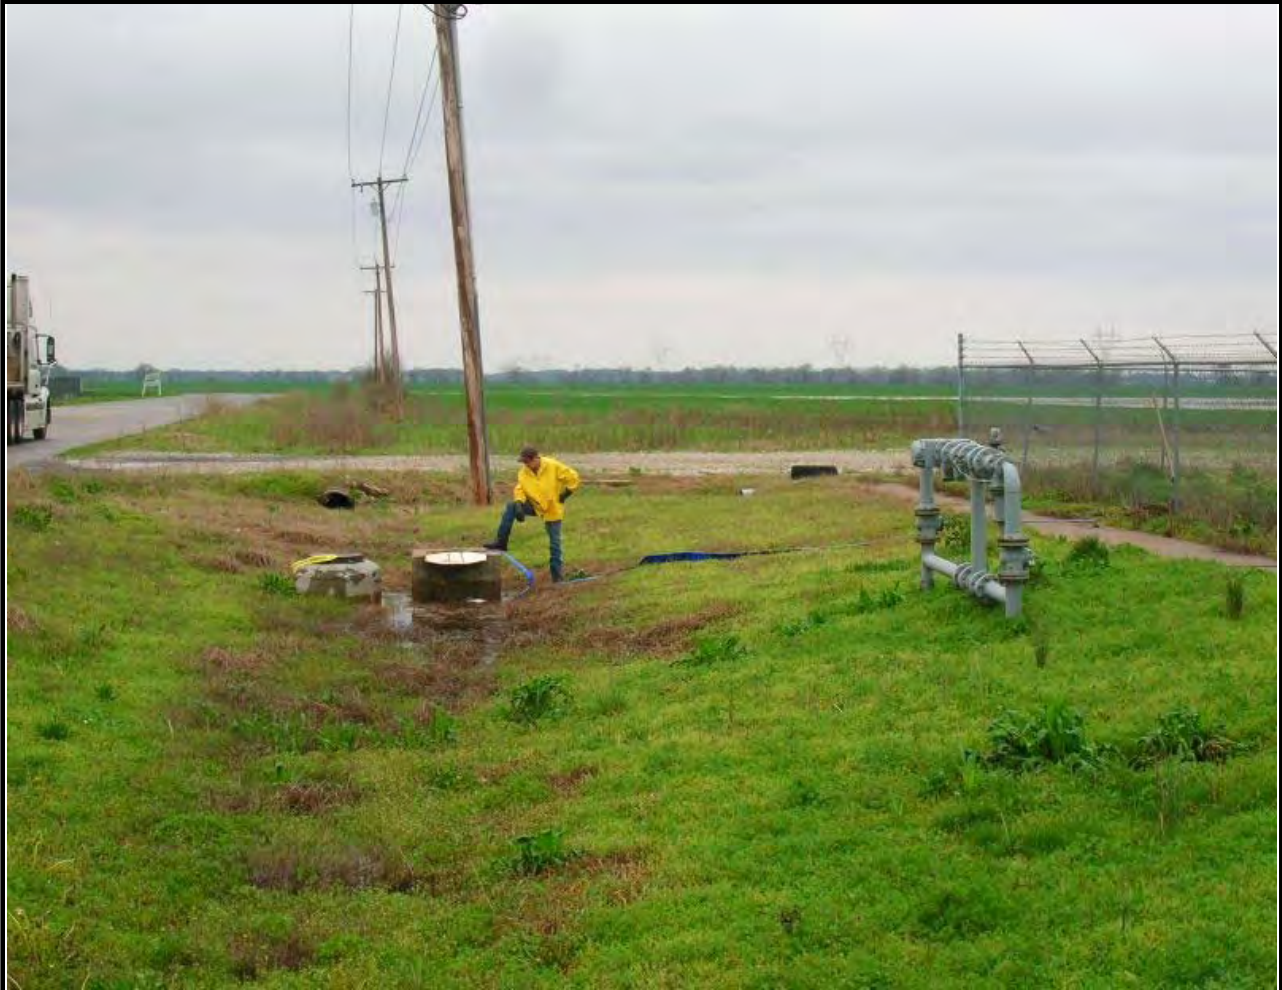
Logbook Photo #	074
US EPA ID / Task Order Number	ARR000005843 / TO-0001-08-01-01
Site	Diaz Intermediates Corporation
Location Address	301 Wyanoke Road
City, State, ZIP code	West Memphis, Arkansas 72301
County	Crittenden
Direction/Orientation	West
Date	04/01/08
Time	0934
Photographer	Troy Naquin, Dynamac START-3
Witness	NA
Description: ERRS monitoring the discharge of pooled storm water from the New Tank Farm secondary containment area into sanitary sewer.

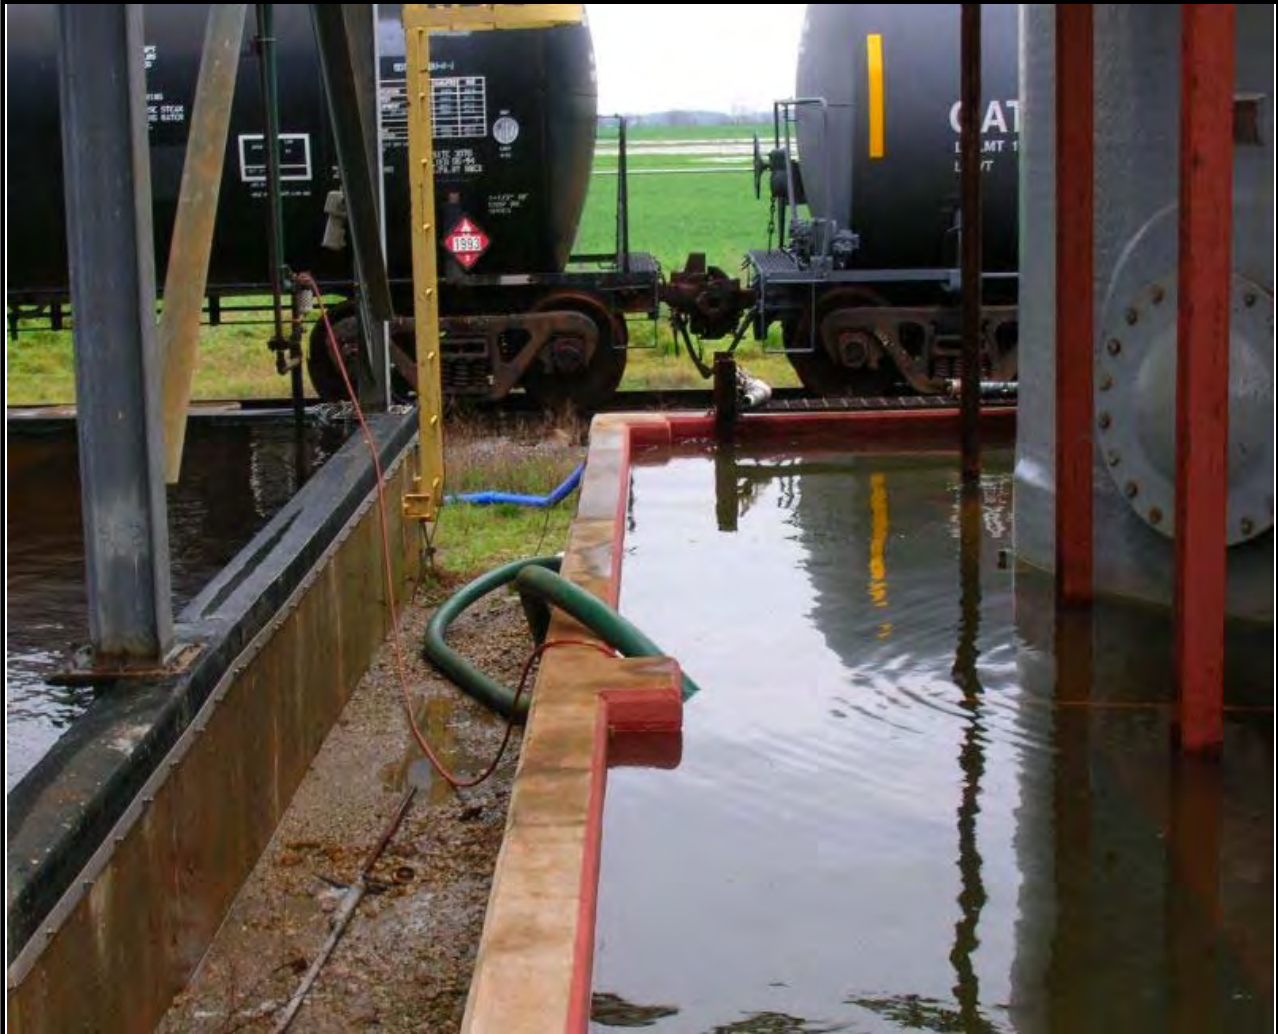
Logbook Photo #	075
US EPA ID / Task Order Number	ARR000005843 / TO-0001-08-01-01
Site	Diaz Intermediates Corporation
Location Address	301 Wyanoke Road
City, State, ZIP code	West Memphis, Arkansas 72301
County	Crittenden
Direction/Orientation	West
Date	04/01/08
Time	0936
Photographer	Troy Naquin, Dynamac START-3
Witness	NA
Description:	Pumping pooled storm water from the New Tank Farm secondary containment area into sanitary sewer.

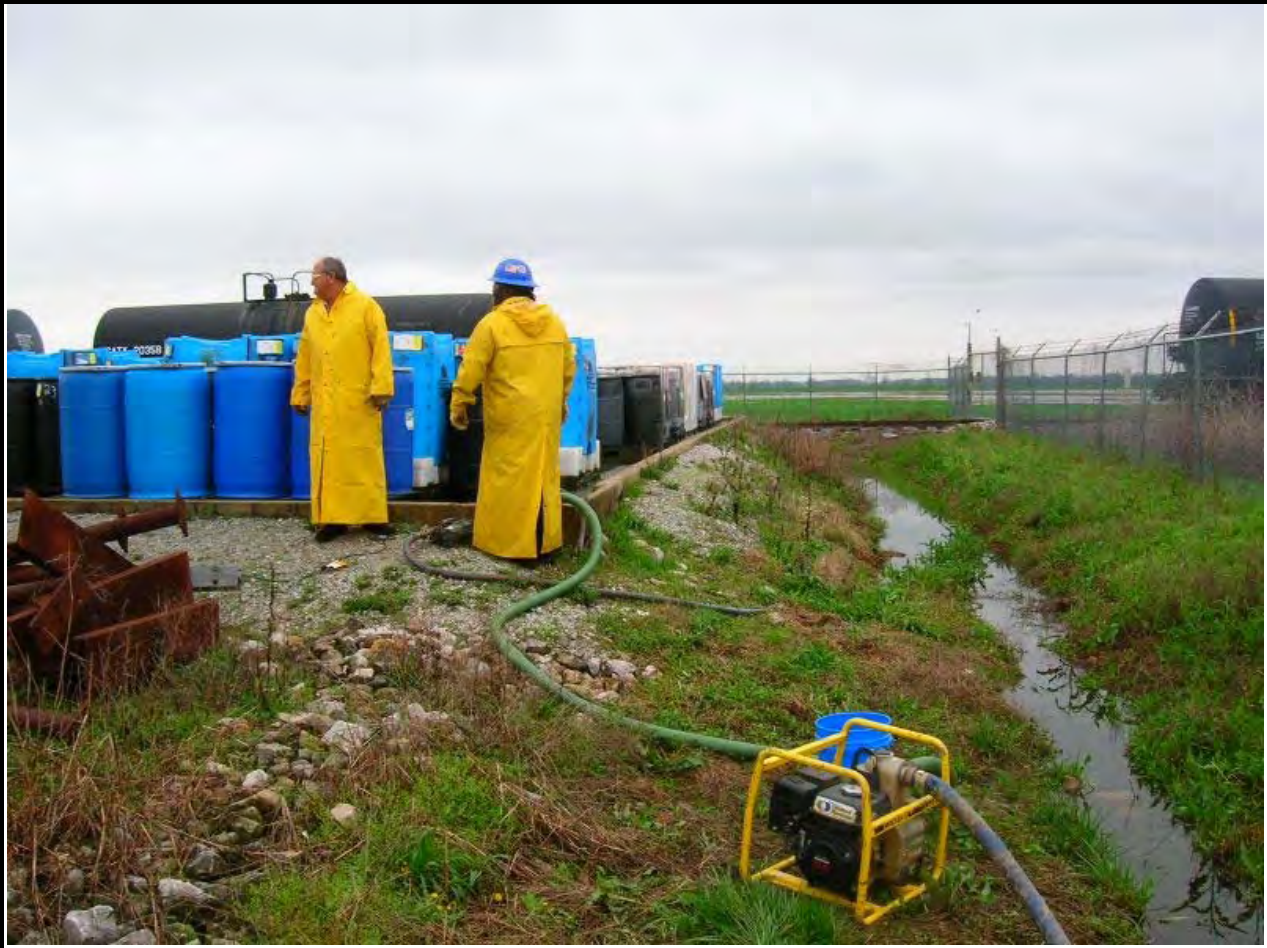
Logbook Photo #	076
US EPA ID / Task Order Number	ARR000005843 / TO-0001-08-01-01
Site	Diaz Intermediates Corporation
Location Address	301 Wyanoke Road
City, State, ZIP code	West Memphis, Arkansas 72301
County	Crittenden
Direction/Orientation	West
Date	04/01/08
Time	0937
Photographer	Troy Naquin, Dynamac START-3
Witness	NA
Description: Pumping pooled storm water from the Drum Pad secondary containment area into the storm water drainage pathway.

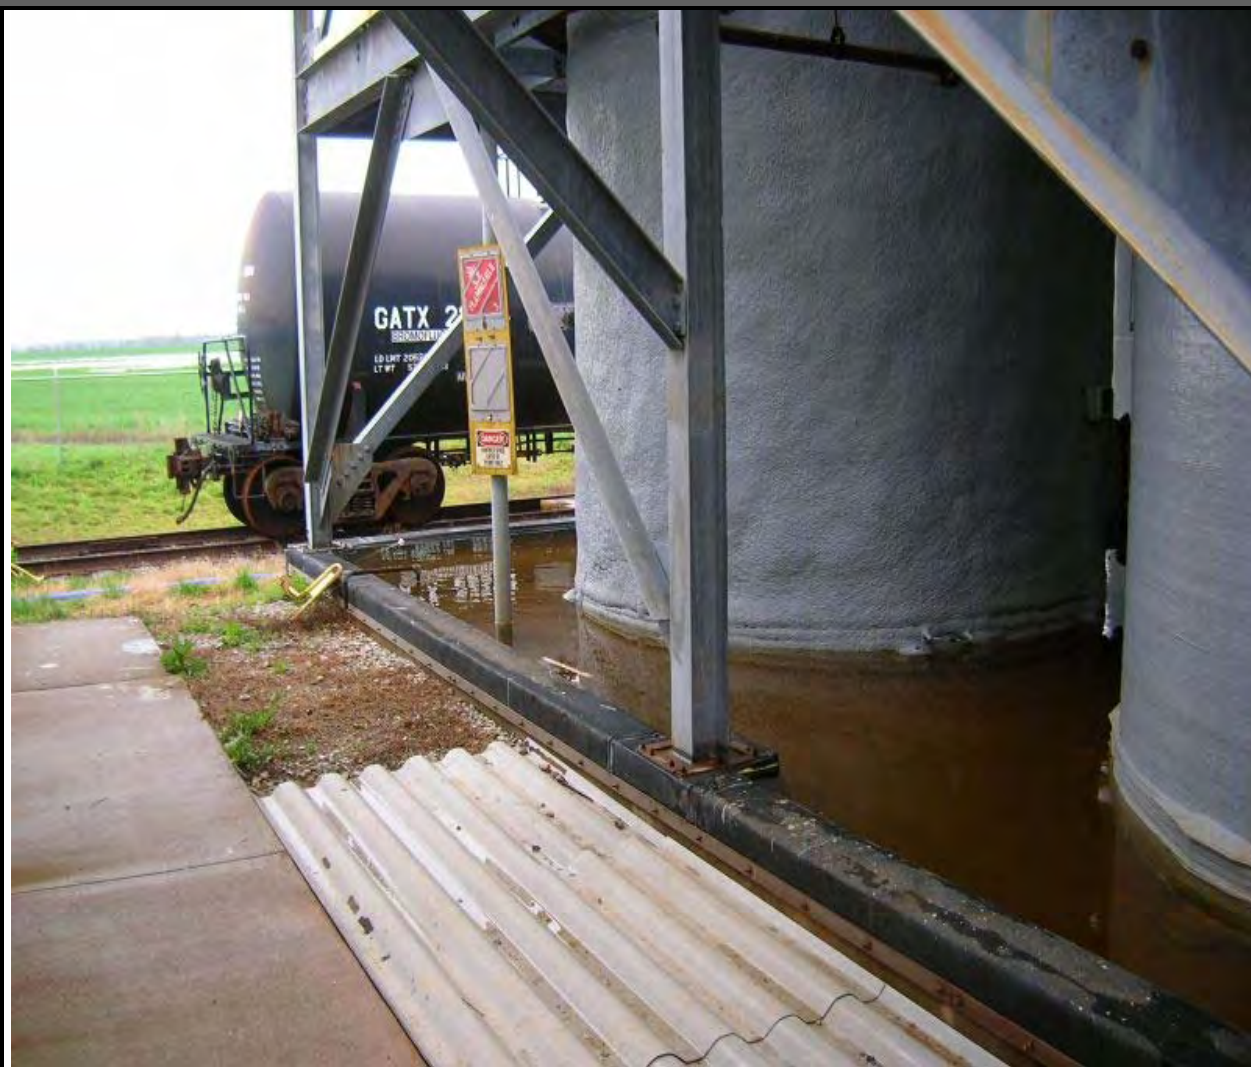
Logbook Photo #	077
US EPA ID / Task Order Number	ARR000005843 / TO-0001-08-01-01
Site	Diaz Intermediates Corporation
Location Address	301 Wyanoke Road
City, State, ZIP code	West Memphis, Arkansas 72301
County	Crittenden
Direction/Orientation	Northwest
Date	04/01/08
Time	0939
Photographer	Troy Naquin, Dynamac START-3
Witness	NA
Description: Pooled storm water from the Old Tank Farm secondary containment area prior to treatment.

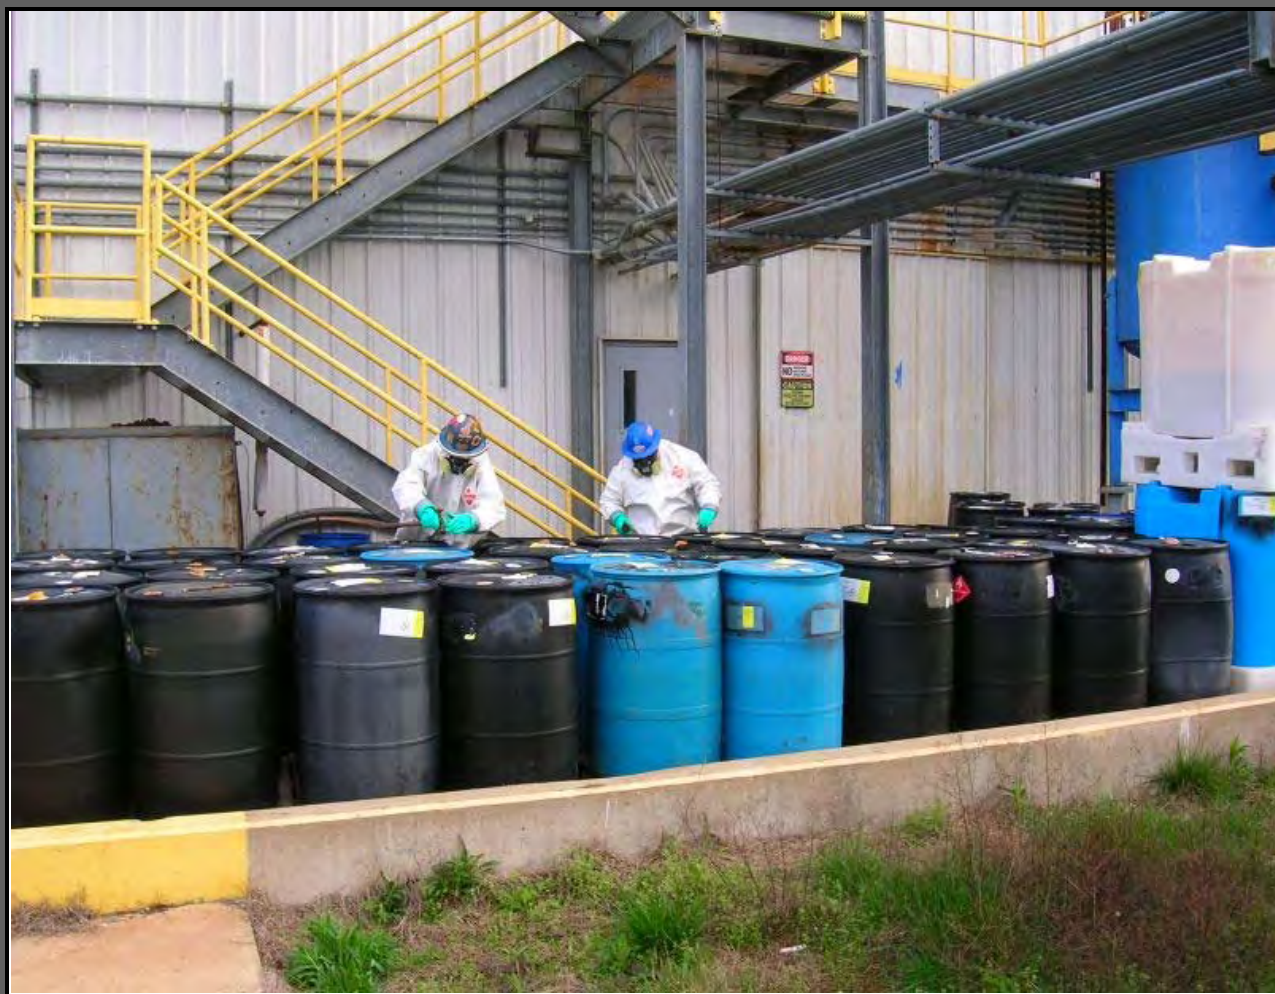
Logbook Photo #	078
US EPA ID / Task Order Number	ARR000005843 / TO-0001-08-01-01
Site	Diaz Intermediates Corporation
Location Address	301 Wyanoke Road
City, State, ZIP code	West Memphis, Arkansas 72301
County	Crittenden
Direction/Orientation	North-Northeast
Date	04/02/08
Time	0803
Photographer	Troy Naquin, Dynamac START-3
Witness	NA
Description: ERRS securing and changing out drum bungs.

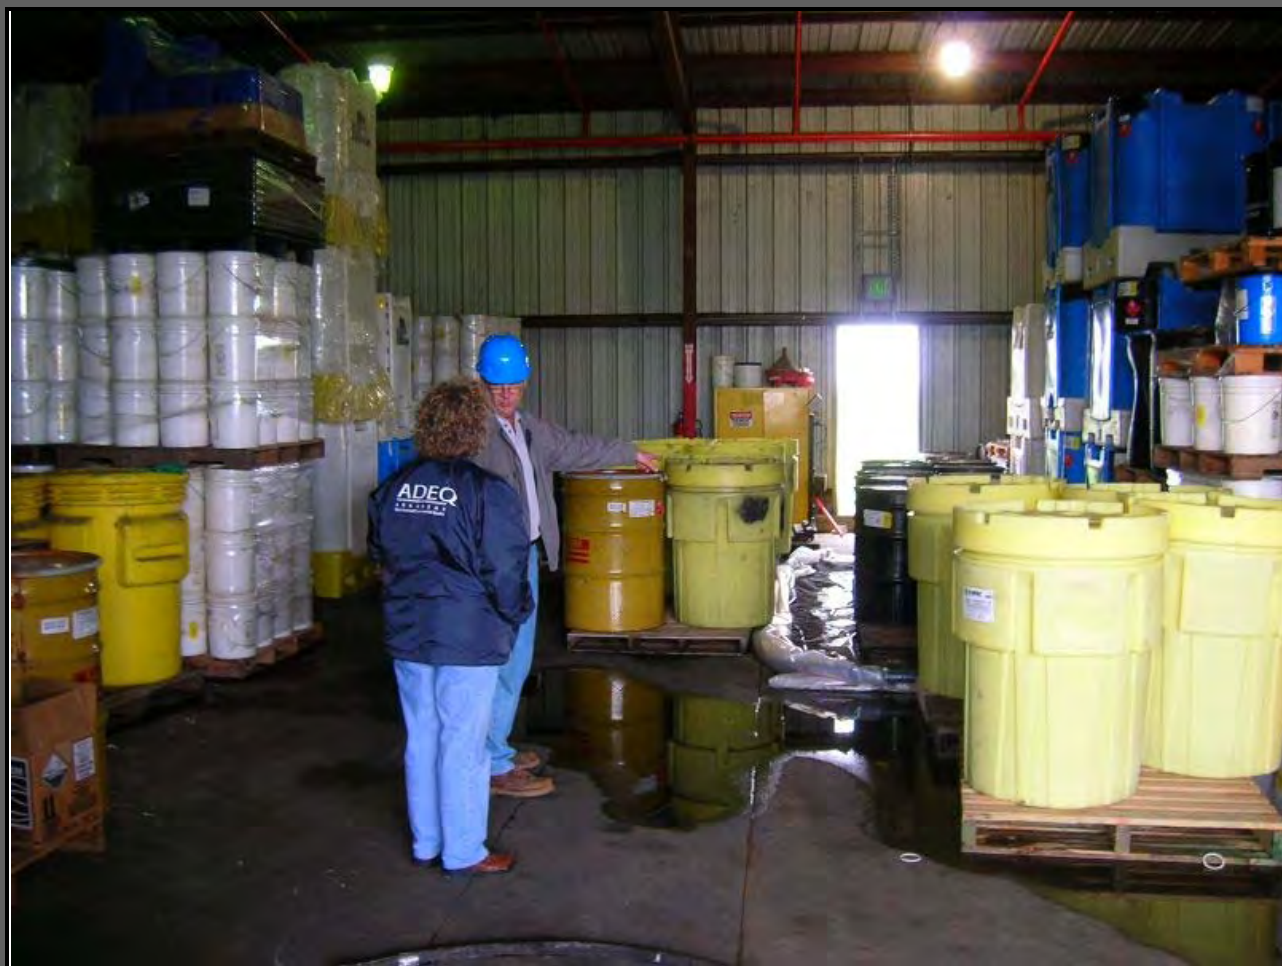
Logbook Photo #	079
US EPA ID / Task Order Number	ARR000005843 / TO-0001-08-01-01
Site	Diaz Intermediates Corporation
Location Address	301 Wyanoke Road
City, State, ZIP code	West Memphis, Arkansas 72301
County	Crittenden
Direction/Orientation	West
Date	04/02/08
Time	1025
Photographer	Troy Naquin, Dynamac START-3
Witness	NA
Description:	EPA touring site with ADEQ representative in Warehouse.

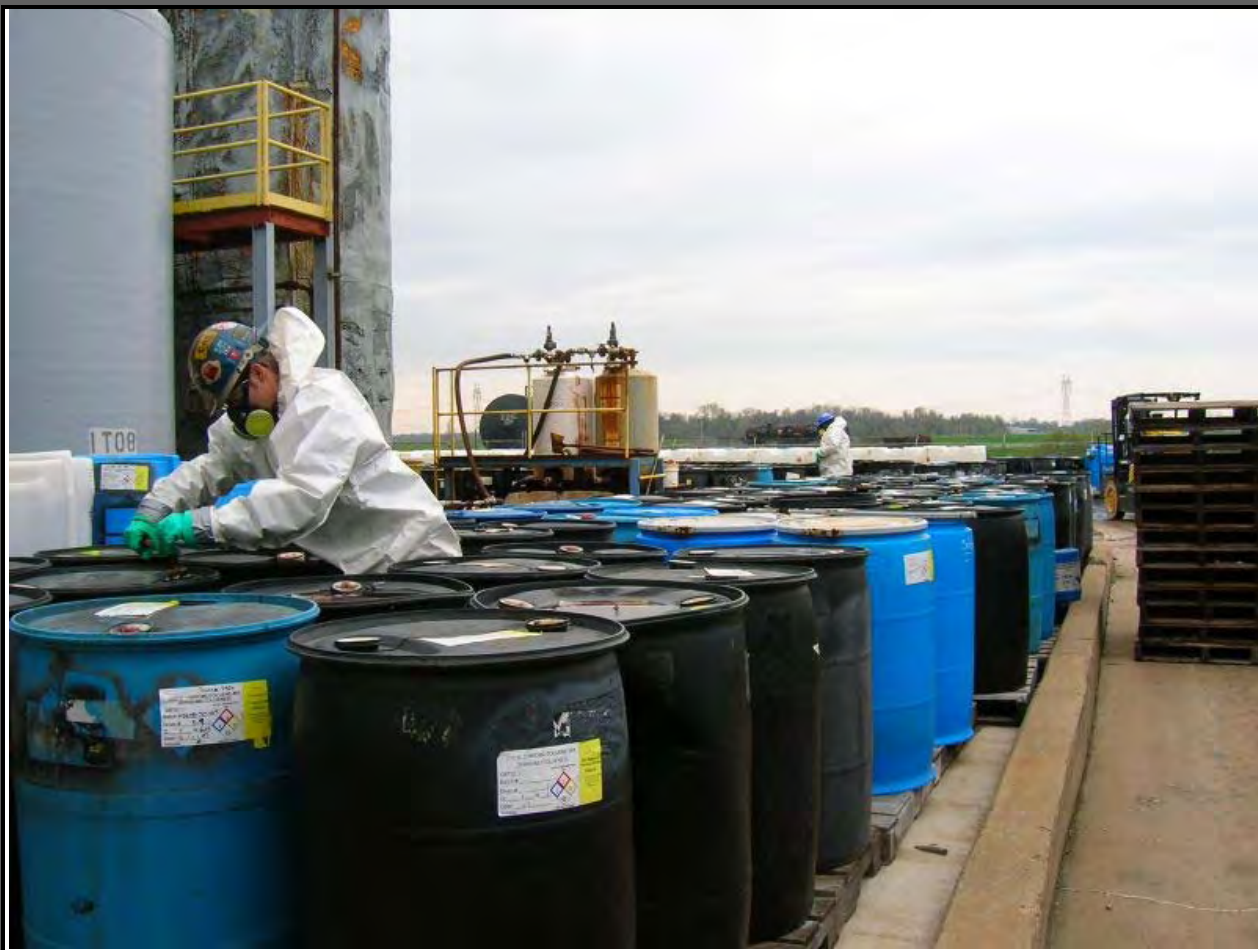
Logbook Photo #	080
US EPA ID / Task Order Number	ARR000005843 / TO-0001-08-01-01
Site	Diaz Intermediates Corporation
Location Address	301 Wyanoke Road
City, State, ZIP code	West Memphis, Arkansas 72301
County	Crittenden
Direction/Orientation	North
Date	04/02/08
Time	1255
Photographer	Troy Naquin, Dynamac START-3
Witness	NA
Description: ERRS securing and changing out drum bungs.

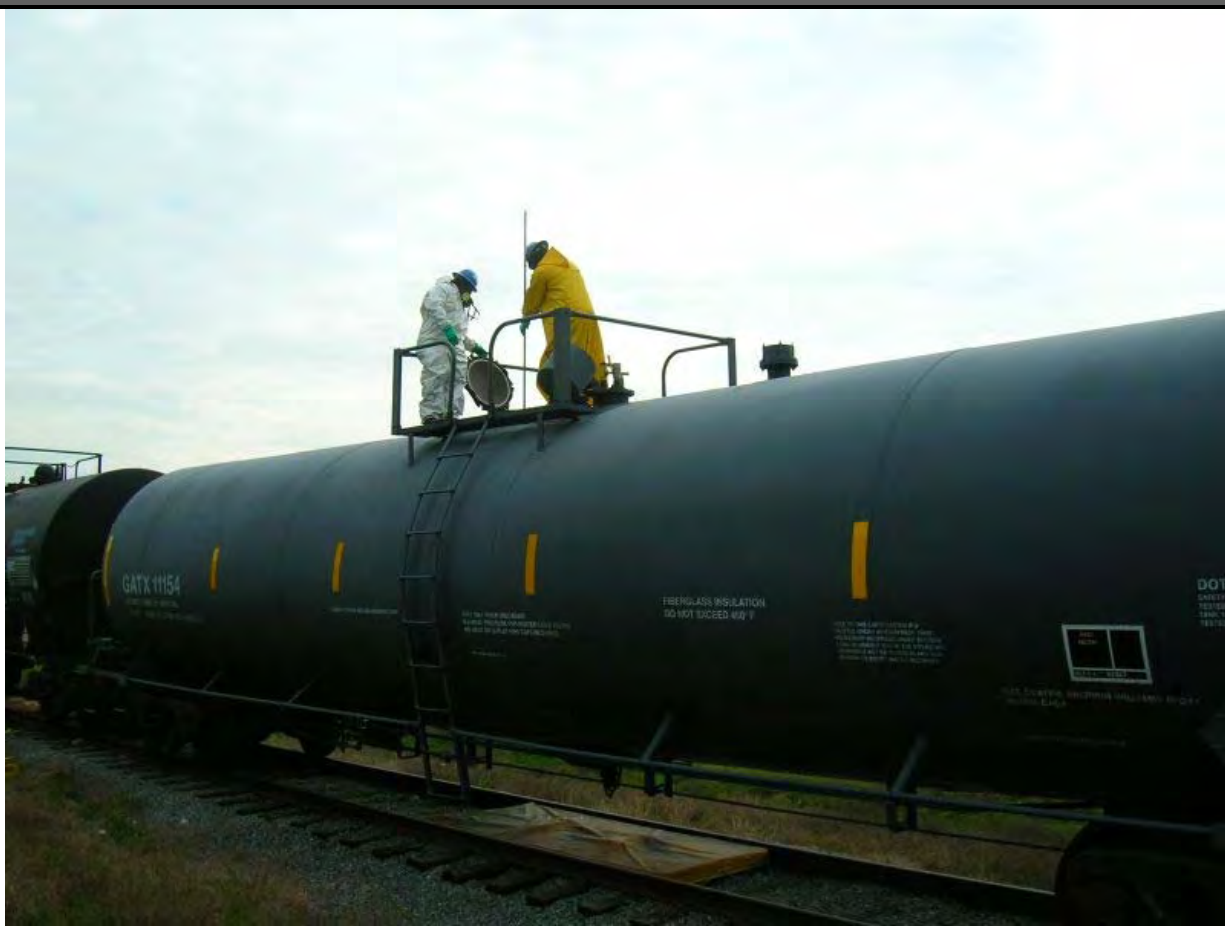
Logbook Photo #	081
US EPA ID / Task Order Number	ARR000005843 / TO-0001-08-01-01
Site	Diaz Intermediates Corporation
Location Address	301 Wyanoke Road
City, State, ZIP code	West Memphis, Arkansas 72301
County	Crittenden
Direction/Orientation	Southwest
Date	04/02/08
Time	1455
Photographer	Troy Naquin, Dynamac START-3
Witness	NA
Description: ERRS gauging a railroad tank car.

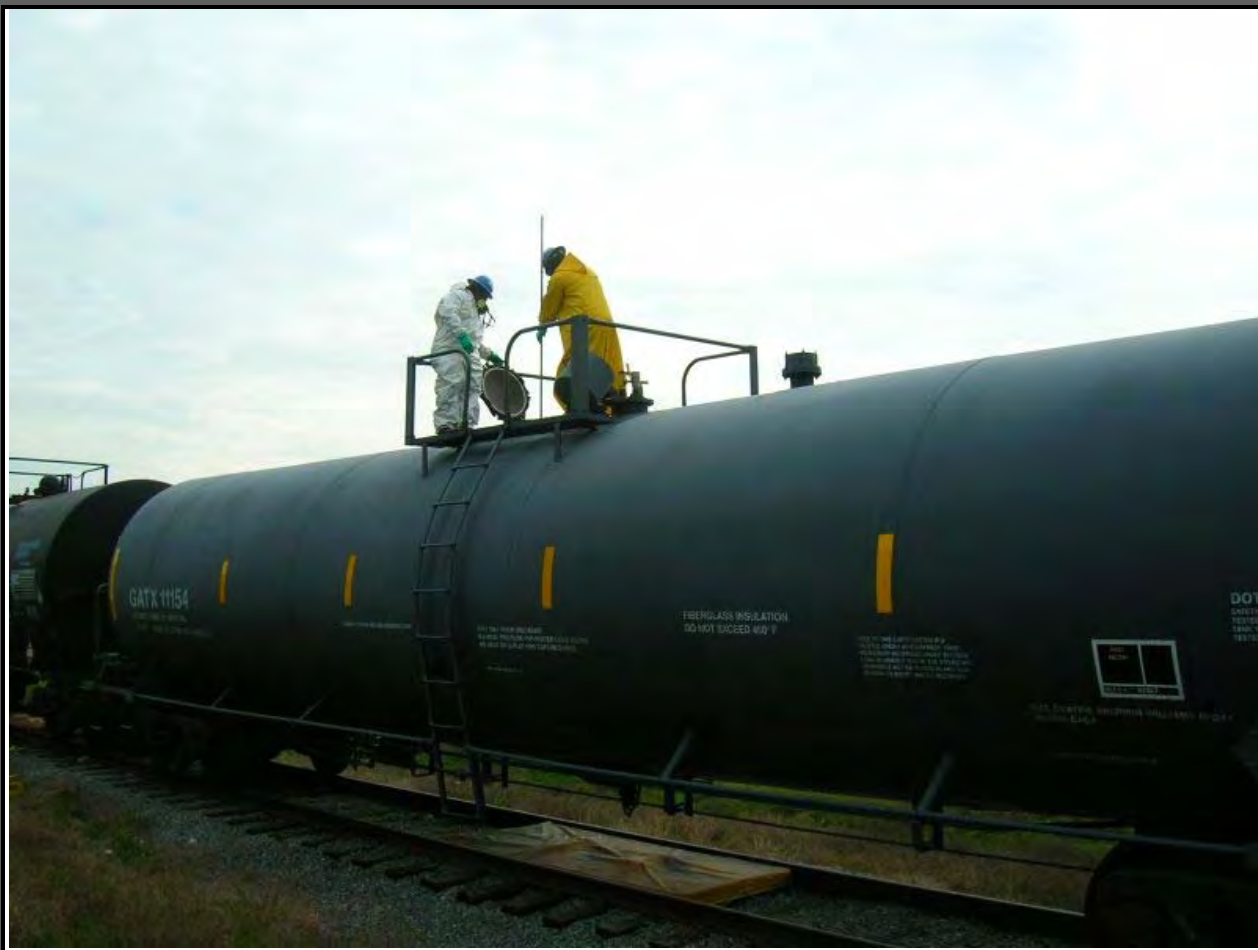
Logbook Photo #	081
US EPA ID / Task Order Number	ARR000005843 / TO-0001-08-01-01
Site	Diaz Intermediates Corporation
Location Address	301 Wyanoke Road
City, State, ZIP code	West Memphis, Arkansas 72301
County	Crittenden
Direction/Orientation	Southwest
Date	04/02/08
Time	1455
Photographer	Troy Naquin, Dynamac START-3
Witness	NA
Description: ERRS gauging a railroad tank car.

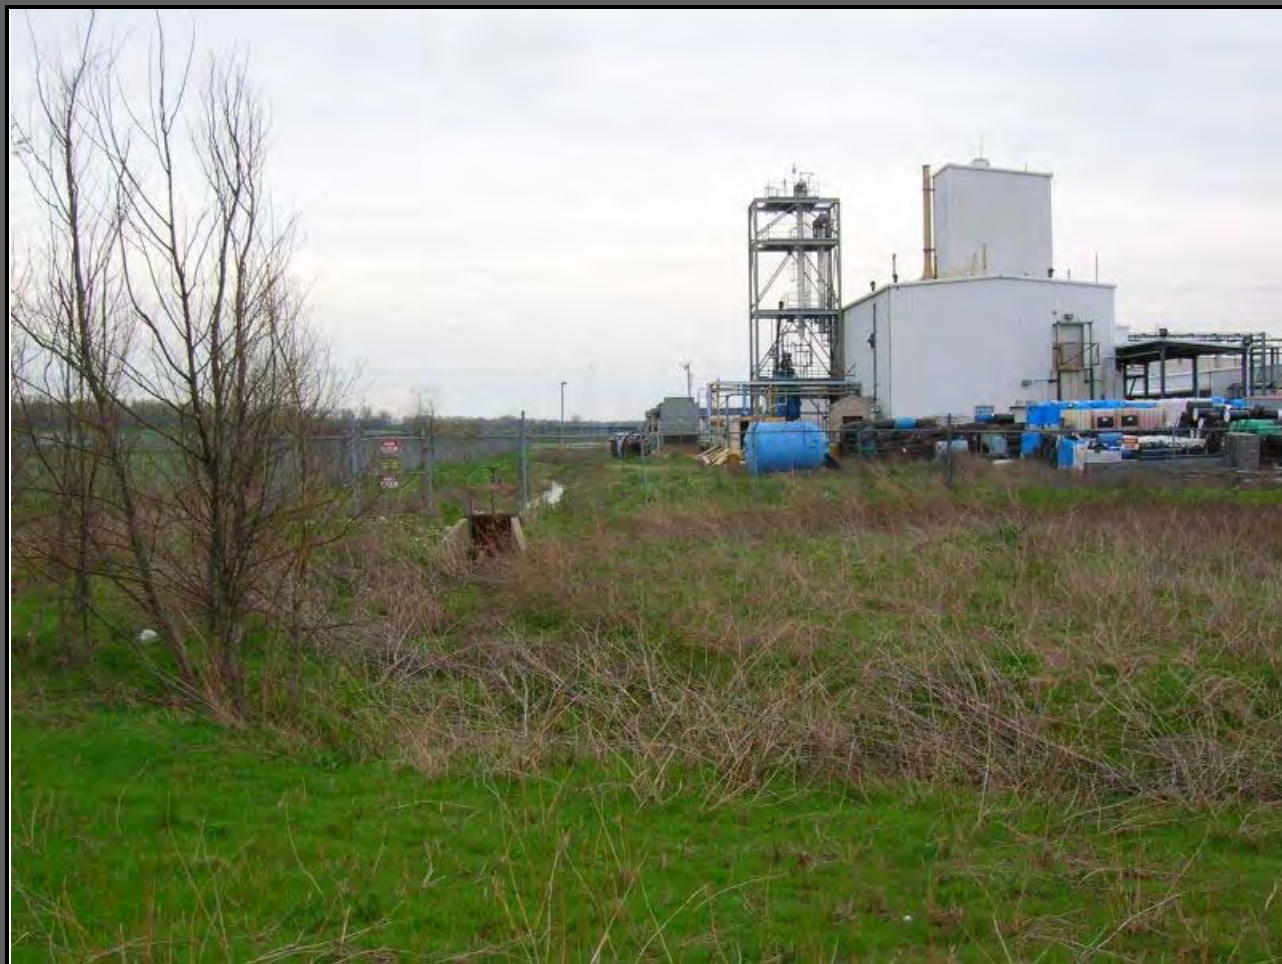
Logbook Photo #	082
US EPA ID / Task Order Number	ARR000005843 / TO-0001-08-01-01
Site	Diaz Intermediates Corporation
Location Address	301 Wyanoke Road
City, State, ZIP code	West Memphis, Arkansas 72301
County	Crittenden
Direction/Orientation	South
Date	04/02/08
Time	1547
Photographer	Troy Naquin, Dynamac START-3
Witness	NA
Description: View of storm water gate and storm water drainage pathway from site.

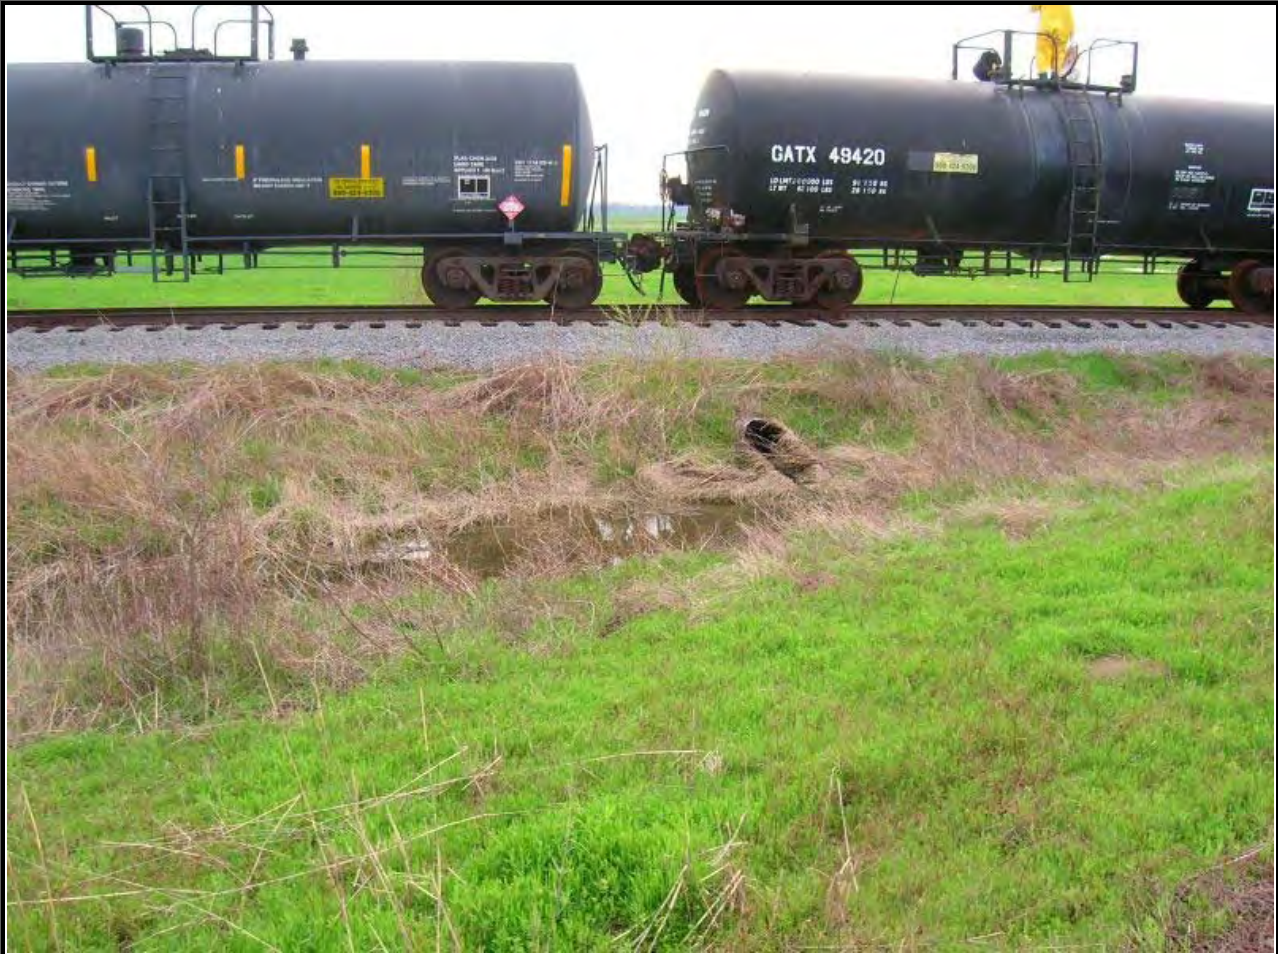
Logbook Photo #	083
US EPA ID / Task Order Number	ARR000005843 / TO-0001-08-01-01
Site	Diaz Intermediates Corporation
Location Address	301 Wyanoke Road
City, State, ZIP code	West Memphis, Arkansas 72301
County	Crittenden
Direction/Orientation	West
Date	04/02/08
Time	1548
Photographer	Troy Naquin, Dynamac START-3
Witness	NA
Description:	View of storm water drainage pathway from site, flowing northwest under railroad tracks.

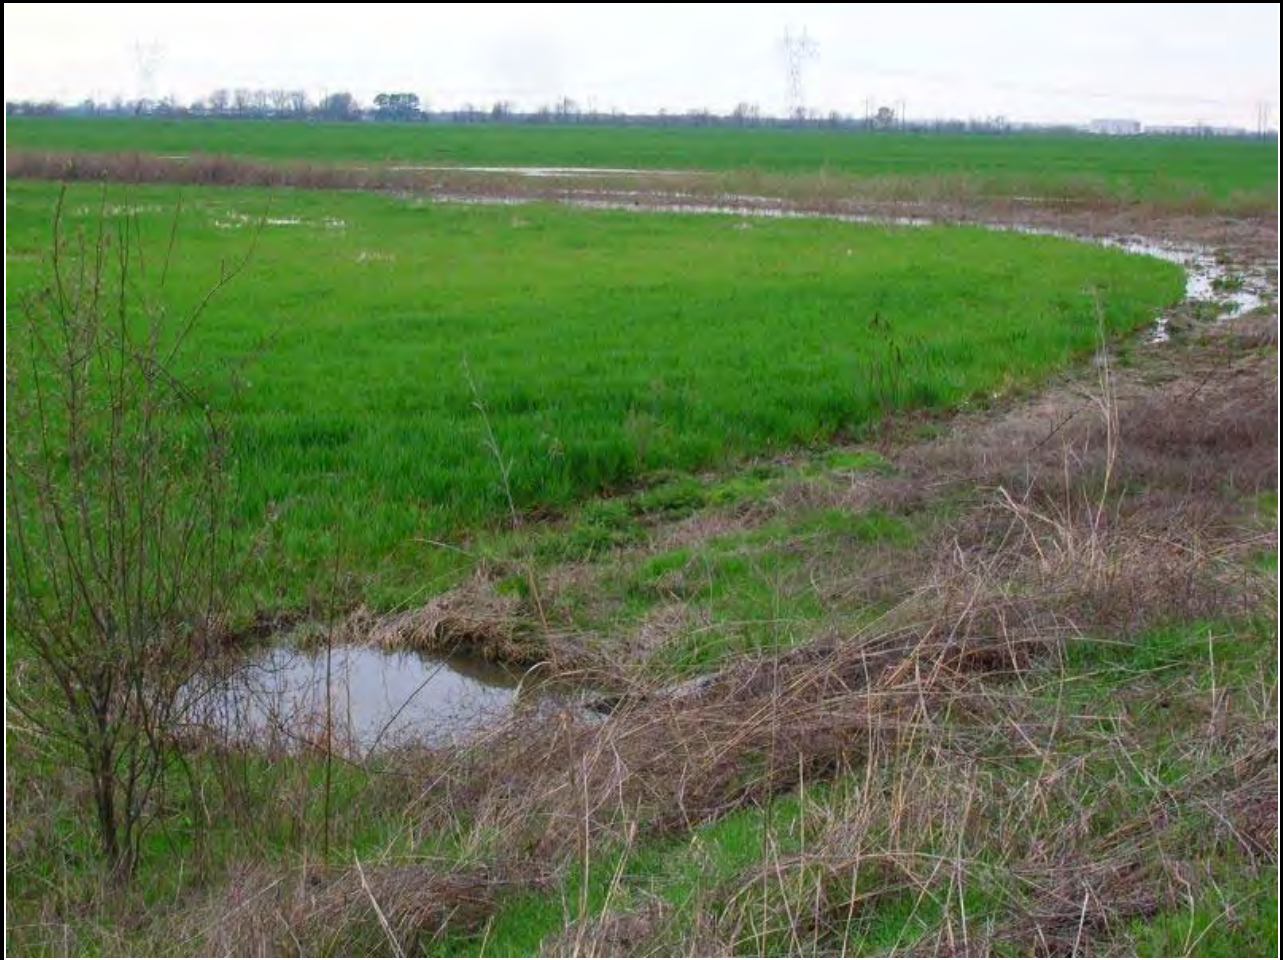
Logbook Photo #	084
US EPA ID / Task Order Number	ARR000005843 / TO-0001-08-01-01
Site	Diaz Intermediates Corporation
Location Address	301 Wyanoke Road
City, State, ZIP code	West Memphis, Arkansas 72301
County	Crittenden
Direction/Orientation	Northwest
Date	04/02/08
Time	1550
Photographer	Troy Naquin, Dynamac START-3
Witness	NA
Description:	View of storm water drainage pathway discharge point from site flowing northwest from under the railroad track into an open field.

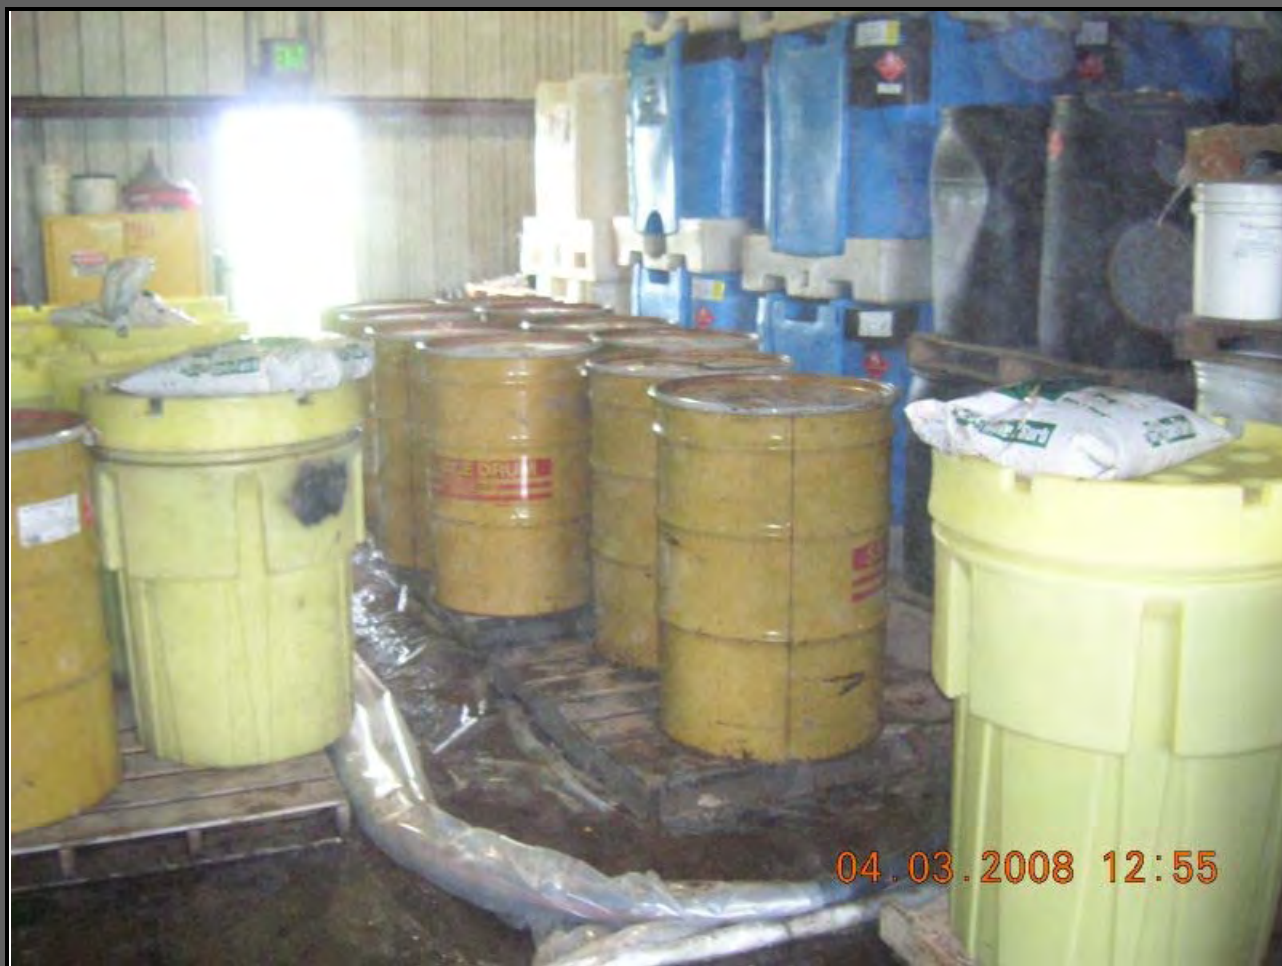
Logbook Photo #	085
US EPA ID / Task Order Number	ARR000005843 / TO-0001-08-01-01
Site	Diaz Intermediates Corporation
Location Address	301 Wyanoke Road
City, State, ZIP code	West Memphis, Arkansas 72301
County	Crittenden
Direction/Orientation	North-Northwest
Date	04/03/08
Time	1255
Photographer	Troy Naquin, Dynamac START-3
Witness	NA
Description:	View of overpack drums containing the 10 drums of dibromobenzene sludge.

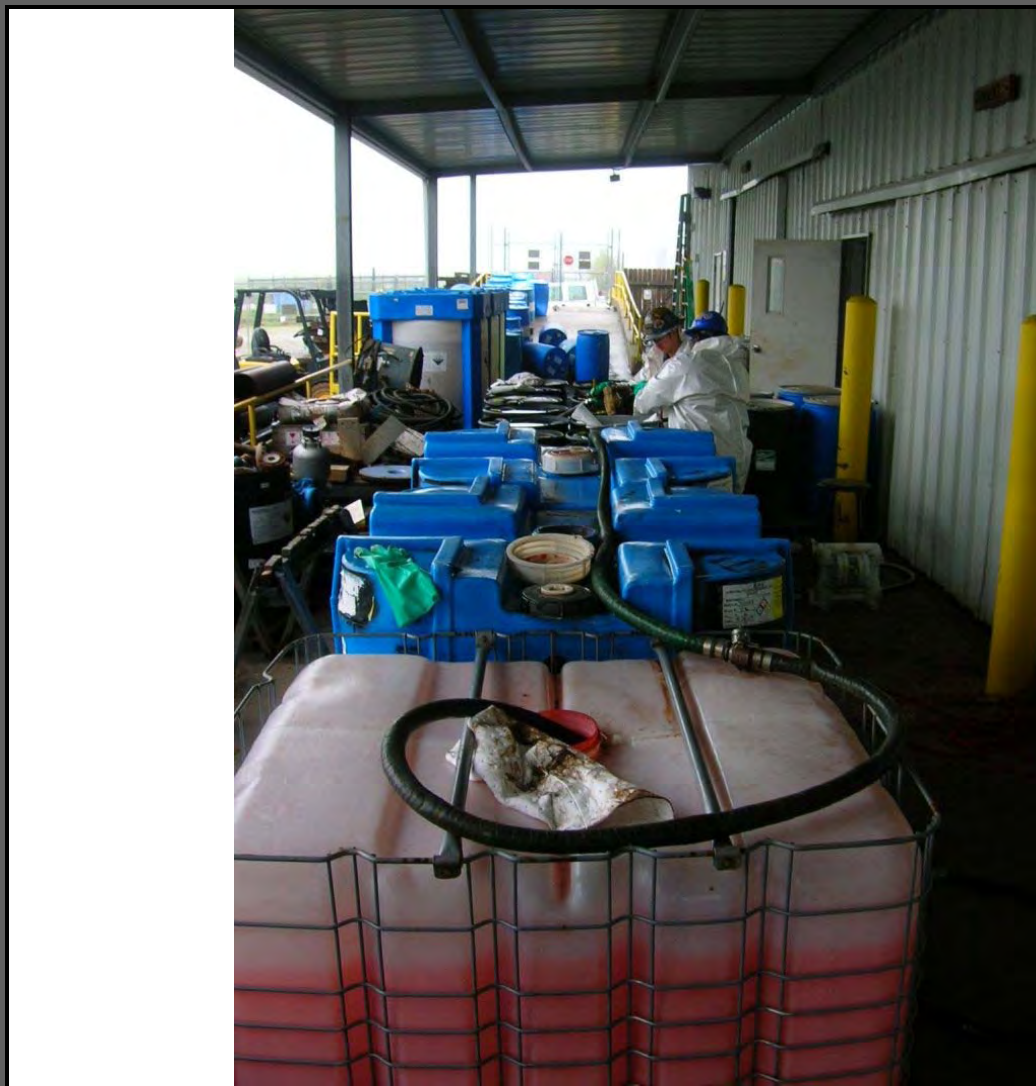
Logbook Photo #	086
US EPA ID / Task Order Number	ARR000005843 / TO-0001-08-01-01
Site	Diaz Intermediates Corporation
Location Address	301 Wyanoke Road
City, State, ZIP code	West Memphis, Arkansas 72301
County	Crittenden
Direction/Orientation	South
Date	04/03/08
Time	1257
Photographer	Troy Naquin, Dynamac START-3
Witness	NA
Description: ERRS transferring contents of deteriorating drums of bromoanisole and bromofluorobenzene into tote tanks for storage.

0925 ERRI began transferring contents of deteriorating dibromobenzene drums into tote tanks. Rain continues to fall.

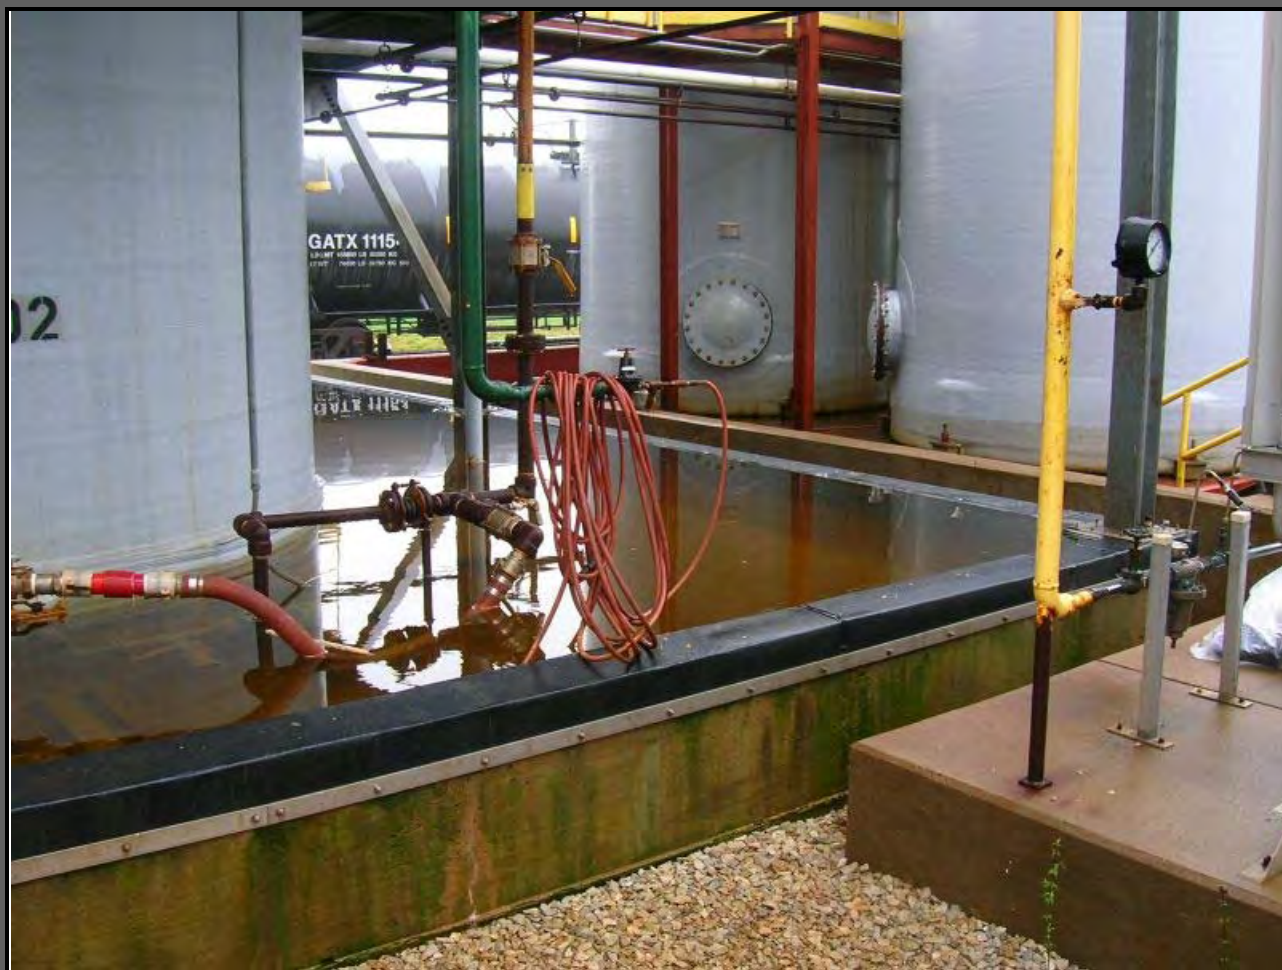
Logbook Photo #	087
US EPA ID / Task Order Number	ARR000005843 / TO-0001-08-01-01
Site	Diaz Intermediates Corporation
Location Address	301 Wyanoke Road
City, State, ZIP code	West Memphis, Arkansas 72301
County	Crittenden
Direction/Orientation	Northwest
Date	04/03/08
Time	1259
Photographer	Troy Naquin, Dynamac START-3
Witness	NA
Description: View of pooled storm water in the Old Tank Farm secondary containment area prior to treatment.

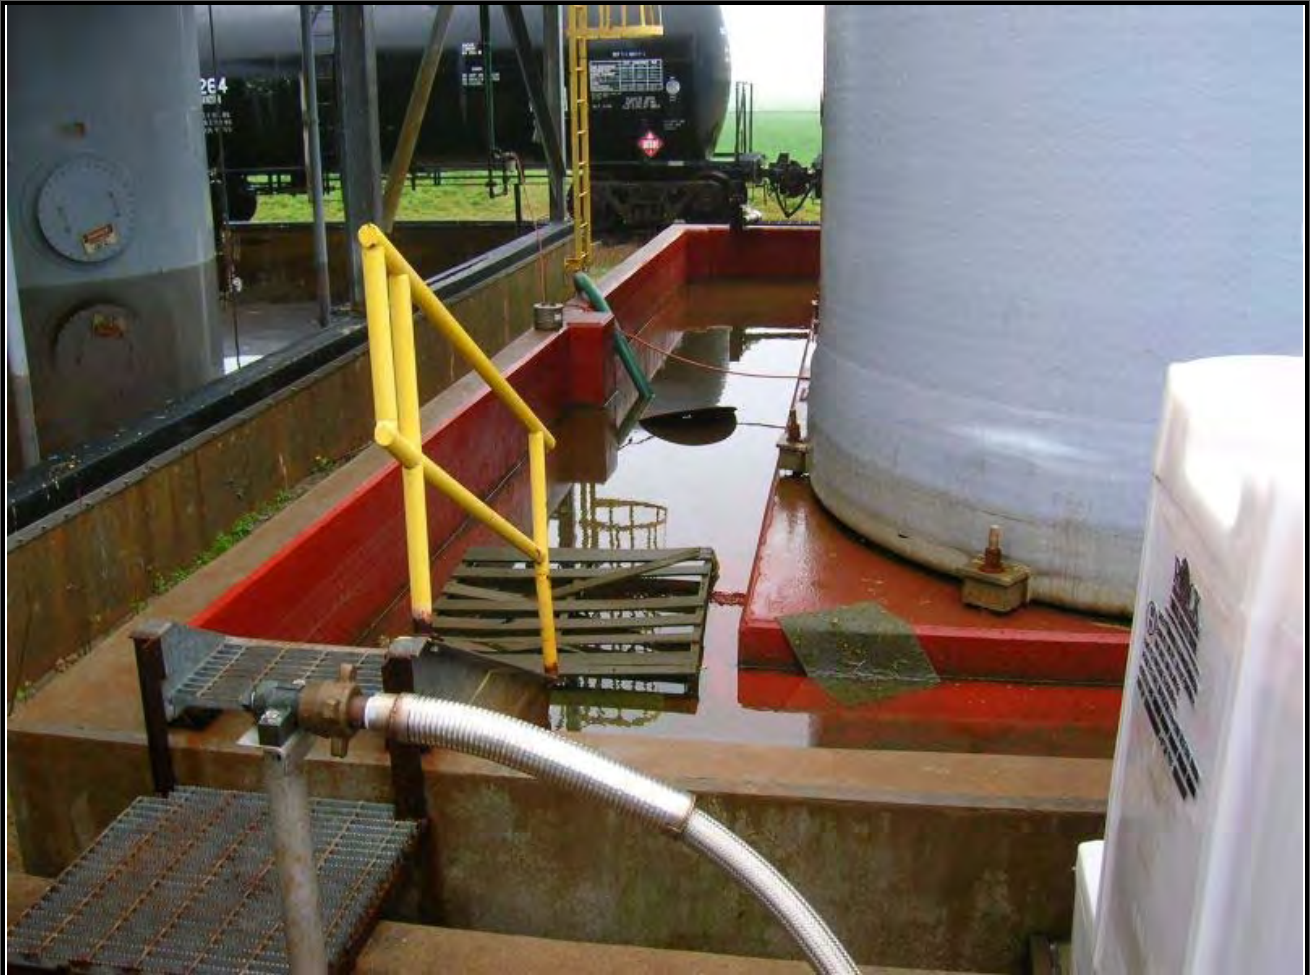
Logbook Photo #	088
US EPA ID / Task Order Number	ARR000005843 / TO-0001-08-01-01
Site	Diaz Intermediates Corporation
Location Address	301 Wyanoke Road
City, State, ZIP code	West Memphis, Arkansas 72301
County	Crittenden
Direction/Orientation	West
Date	04/03/08
Time	1259
Photographer	Troy Naquin, Dynamac START-3
Witness	NA
Description:	View of pooled storm water in the New Tank Farm secondary containment area being pumped out into the sanitary sewer.

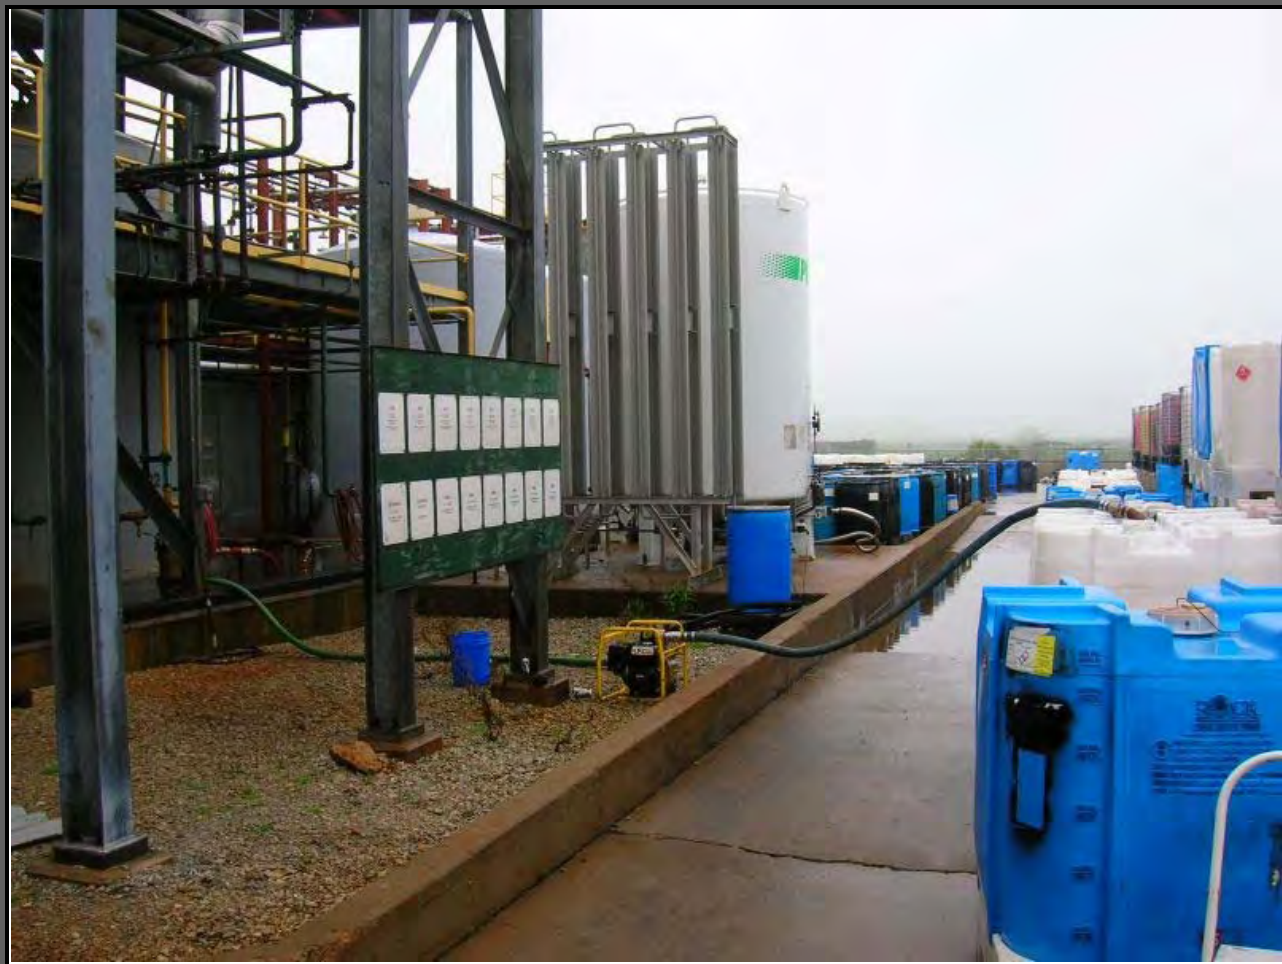
Logbook Photo #	089
US EPA ID / Task Order Number	ARR000005843 / TO-0001-08-01-01
Site	Diaz Intermediates Corporation
Location Address	301 Wyanoke Road
City, State, ZIP code	West Memphis, Arkansas 72301
County	Crittenden
Direction/Orientation	North-Northwest
Date	04/03/08
Time	1311
Photographer	Troy Naquin, Dynamac START-3
Witness	NA
Description: Pumping out of pooled storm water in the Old Tank Farm secondary containment area into a tote tank for bench scale testing.
